Manhole Inspection Summary

Manhole # S17E1_019MH

Insp Date: **2/16/09 1:59 PM**

Location Address: **2831 MAUDLIN AV**

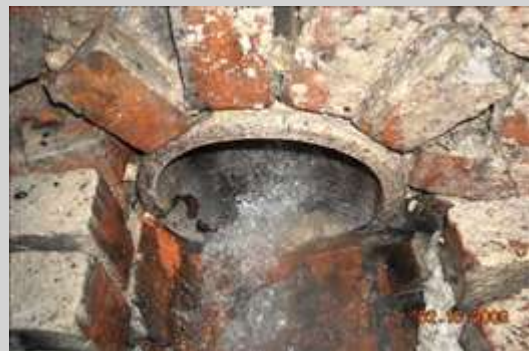
Drop In @ 6 O'Clock

Drop: **Outside** Rod and Bar
Angled: **Yes** Reading: **14.40** (ft.)
Inv Depth: **15.40** (ft.)
Drop Condition: **Open**
